DRINKING WATER STATE REVOLVING LOAN FUND PROGRAM

CATEGORICAL EXCLUSION

PROJECT NAME: Water Tower Repainting
APPLICANT: Clarkson, Nebraska
COUNTY: Colfax
POPULATION: 658 (2010 Census)
DWSRF PROJECT NUMBER: D311014
TOTAL PROJECT AMOUNT: \$308,215

Lower Elkhorn Tank
City Of Clarkson
Report of Findings
From the
Diving Operations
Conducted on
June 4, 2015

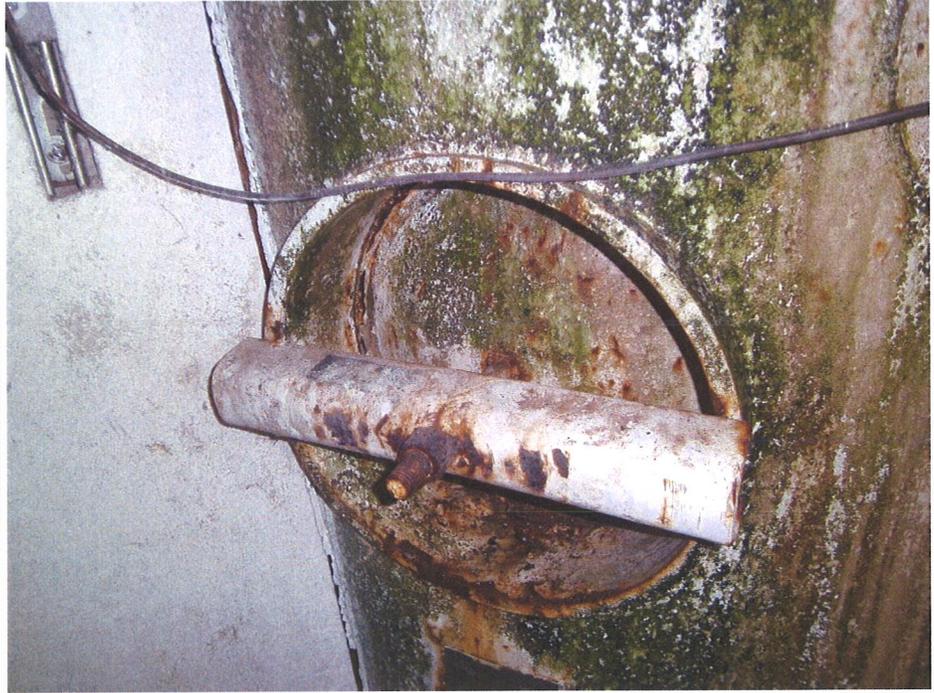
Image #1

Condition:
Rust Grade¹ 4.

Description:
16" Man Way
appeared to be in fair
condition with a
moderate amount of
corrosion.

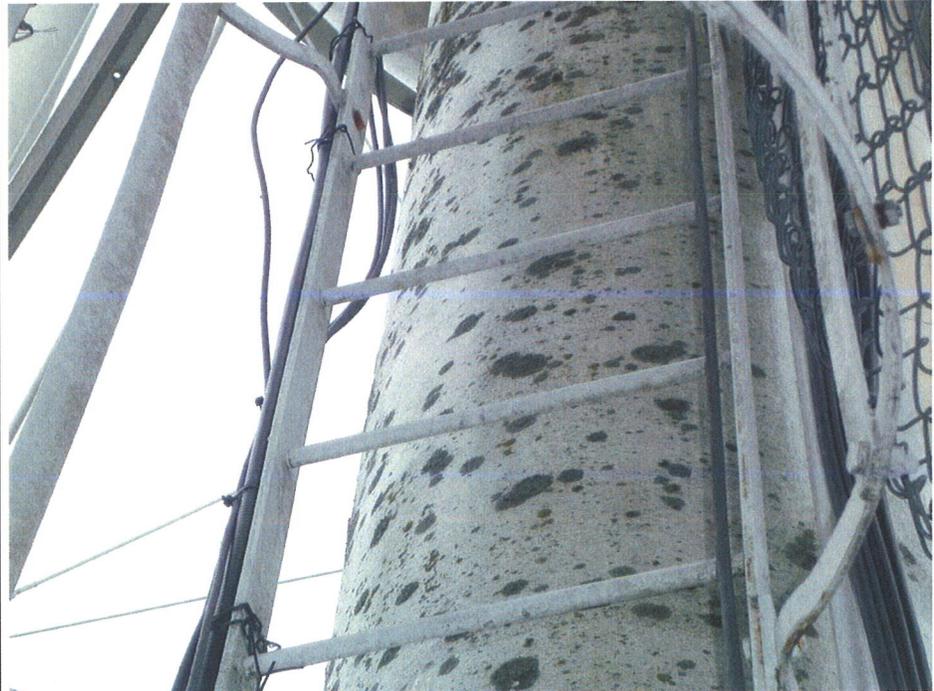
Image #2

Condition:
Rust Grade¹ 7.

Description:
Exterior Ladder
appeared to be in good
condition with a minor
amount of corrosion.

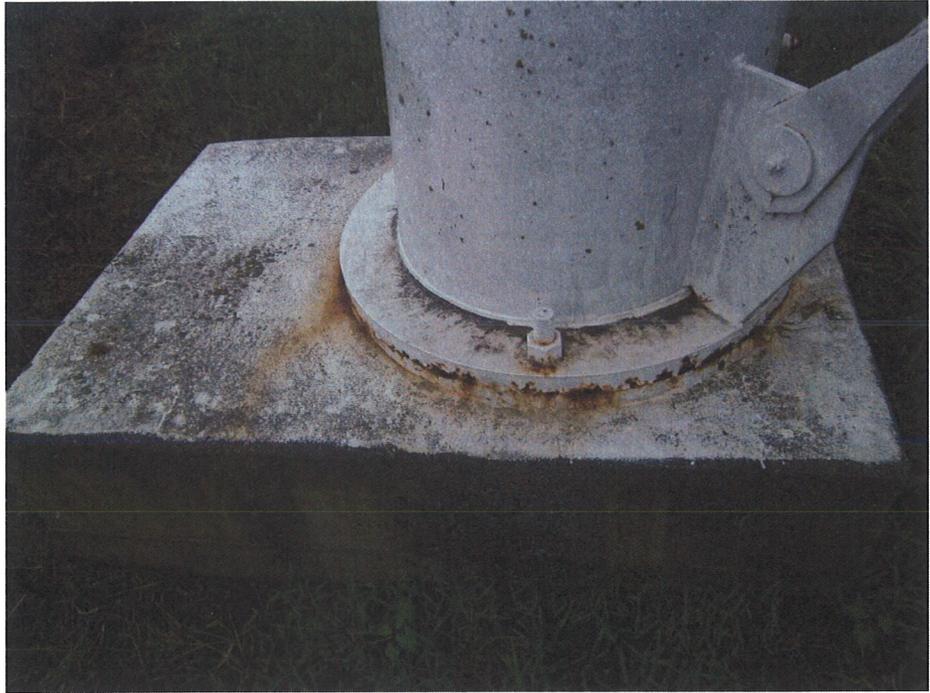
Image #3

Condition:
Concrete Deform³ GC.

Description:
48"x52" Exterior Base appeared to be in good condition with no concrete problems.

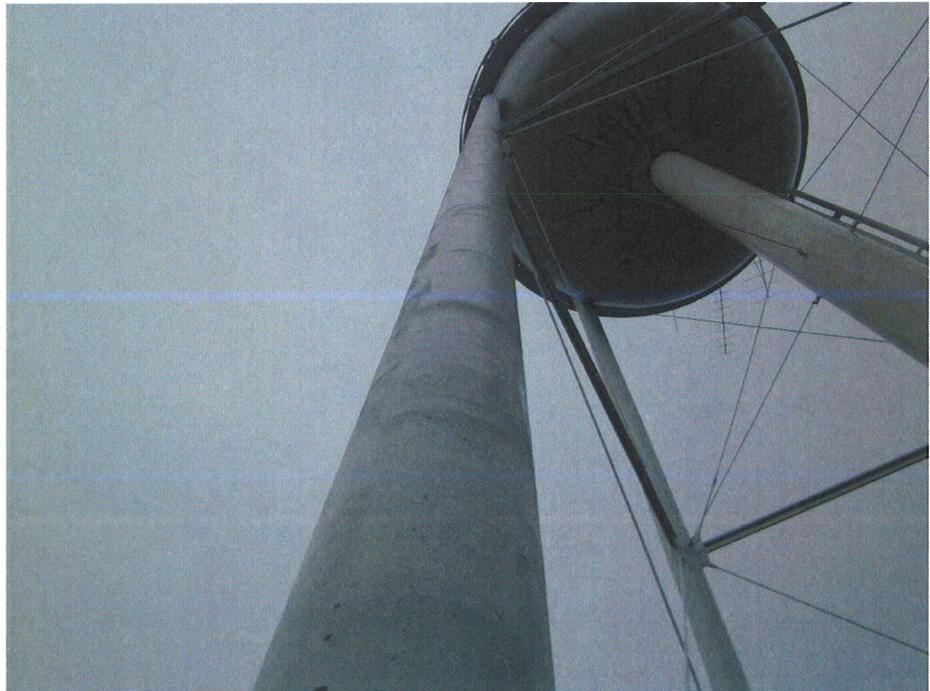
Image #4

Condition:
Rust Grade¹ 8.

Description:
24" Exterior Leg appeared to be in good condition with a minor amount of corrosion.

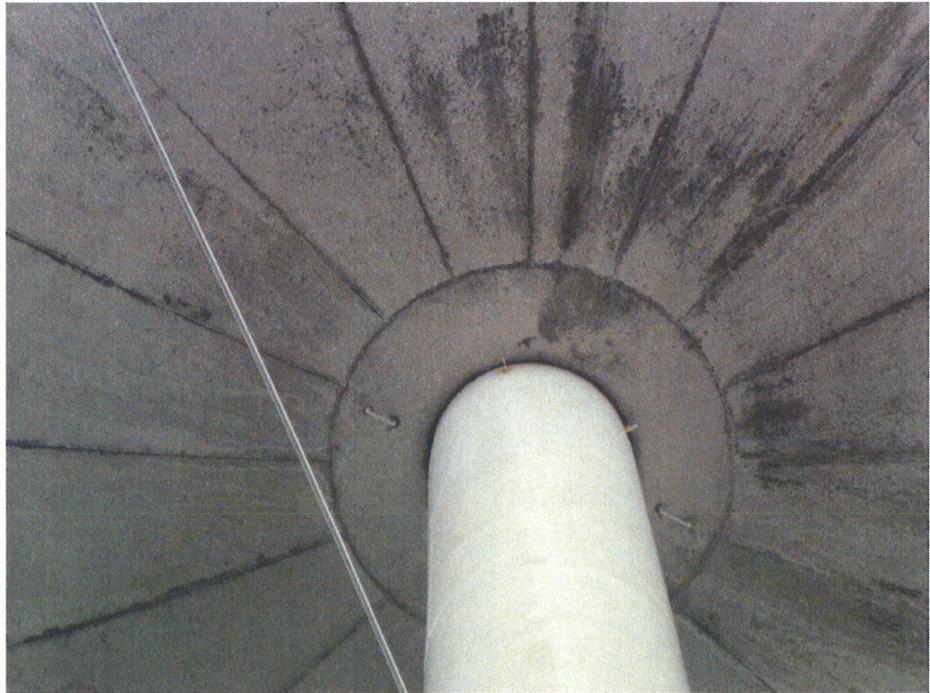
Image #5

Condition:
Rust Grade¹ 8.

Description:
Inlet/Outlet appeared to be in good condition with minor amount of corrosion.

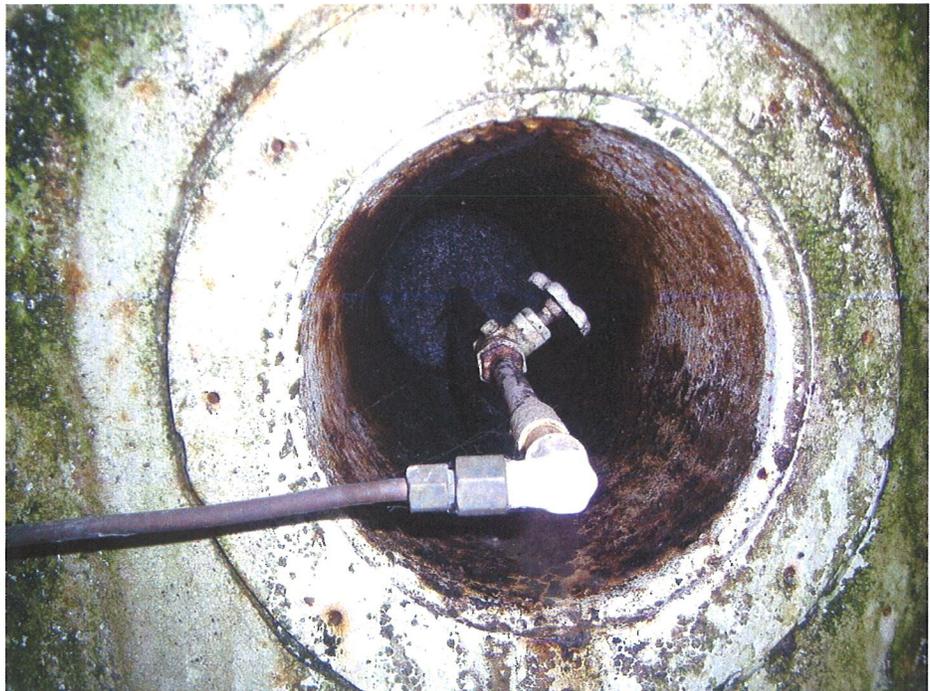
Image #6

Condition:
Rust Grade¹ 5.

Description:
1/2" Water Tap appeared to be in fair condition with a moderate amount of corrosion.

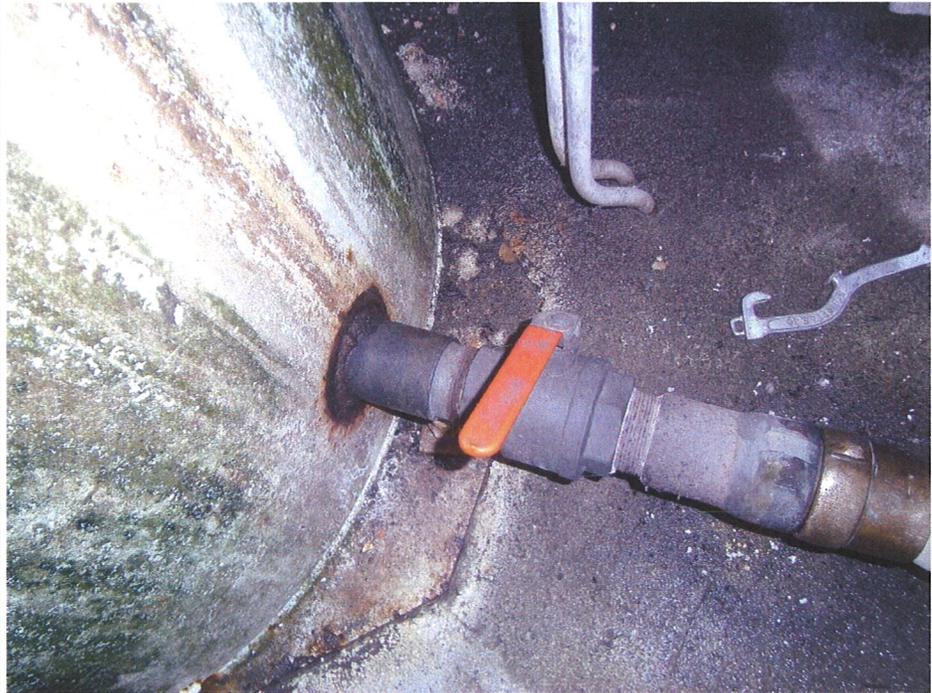
Image #7

Condition:
Rust Grade¹ 6.

Description:
4" Drain appeared to be in fair condition with a moderate amount of corrosion. Drain connects halfway up the Inlet/Outlet.

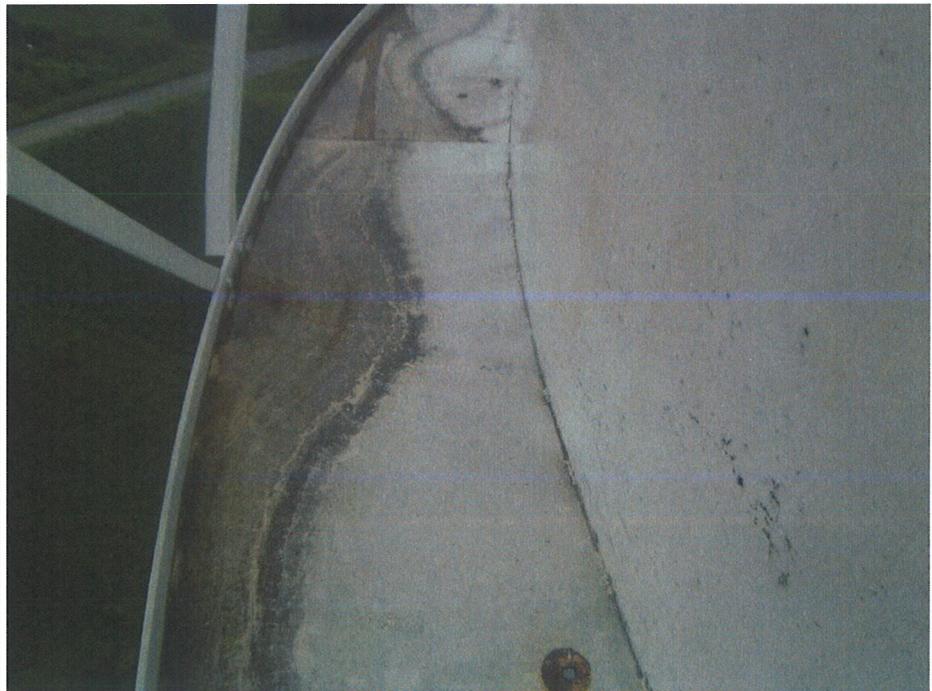
Image #8

Condition:
Rust Grade¹ 8.

Description:
Cat Walk appeared to be in good condition with a minor amount of corrosion.

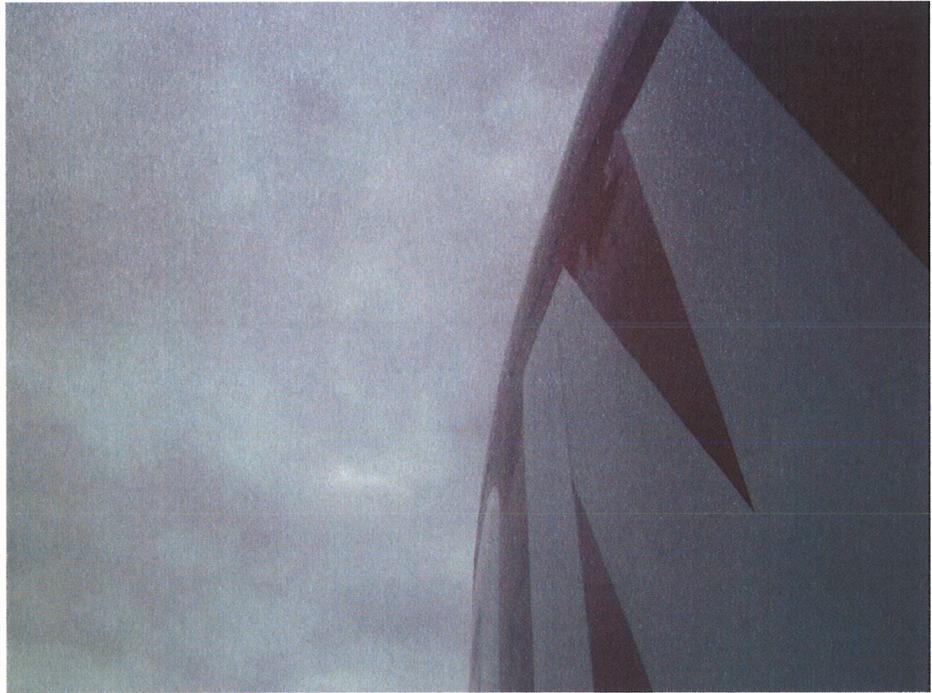
Image #9

Condition:
Rust Grade¹ 8.

Description:
Exterior Wall appeared to be in good condition with a minor amount of corrosion.

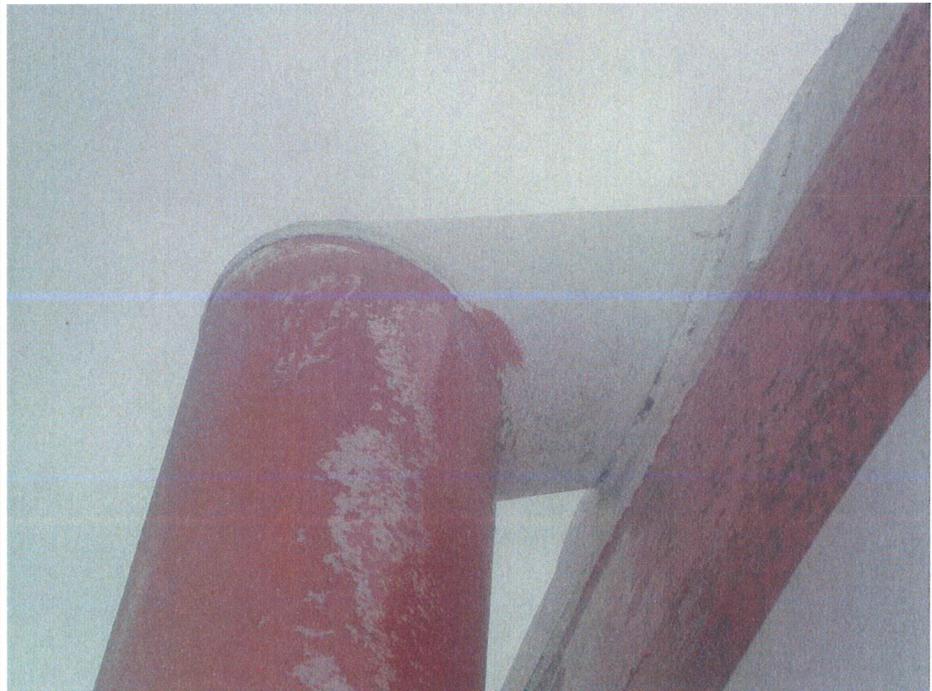
Image #10

Condition:
Rust Grade¹ 8.

Description:
8" Overflow appeared to be in good condition with a minor amount of corrosion.
