SITE MAP NORTH JEFFERS PETROLEUM SITES NORTH JEFFERS STREET NORTH PLATTE, NEBRASKA		
Project Mngr:	KAC	Project No. 05037186
Designed By:	KAC	Scale: AS SHOWN
Drawn By:	PAI	File No. 05037186C14
Checked By:	KAC	Date: MAY 2008
Approved By:	MEH	Figure No. 2

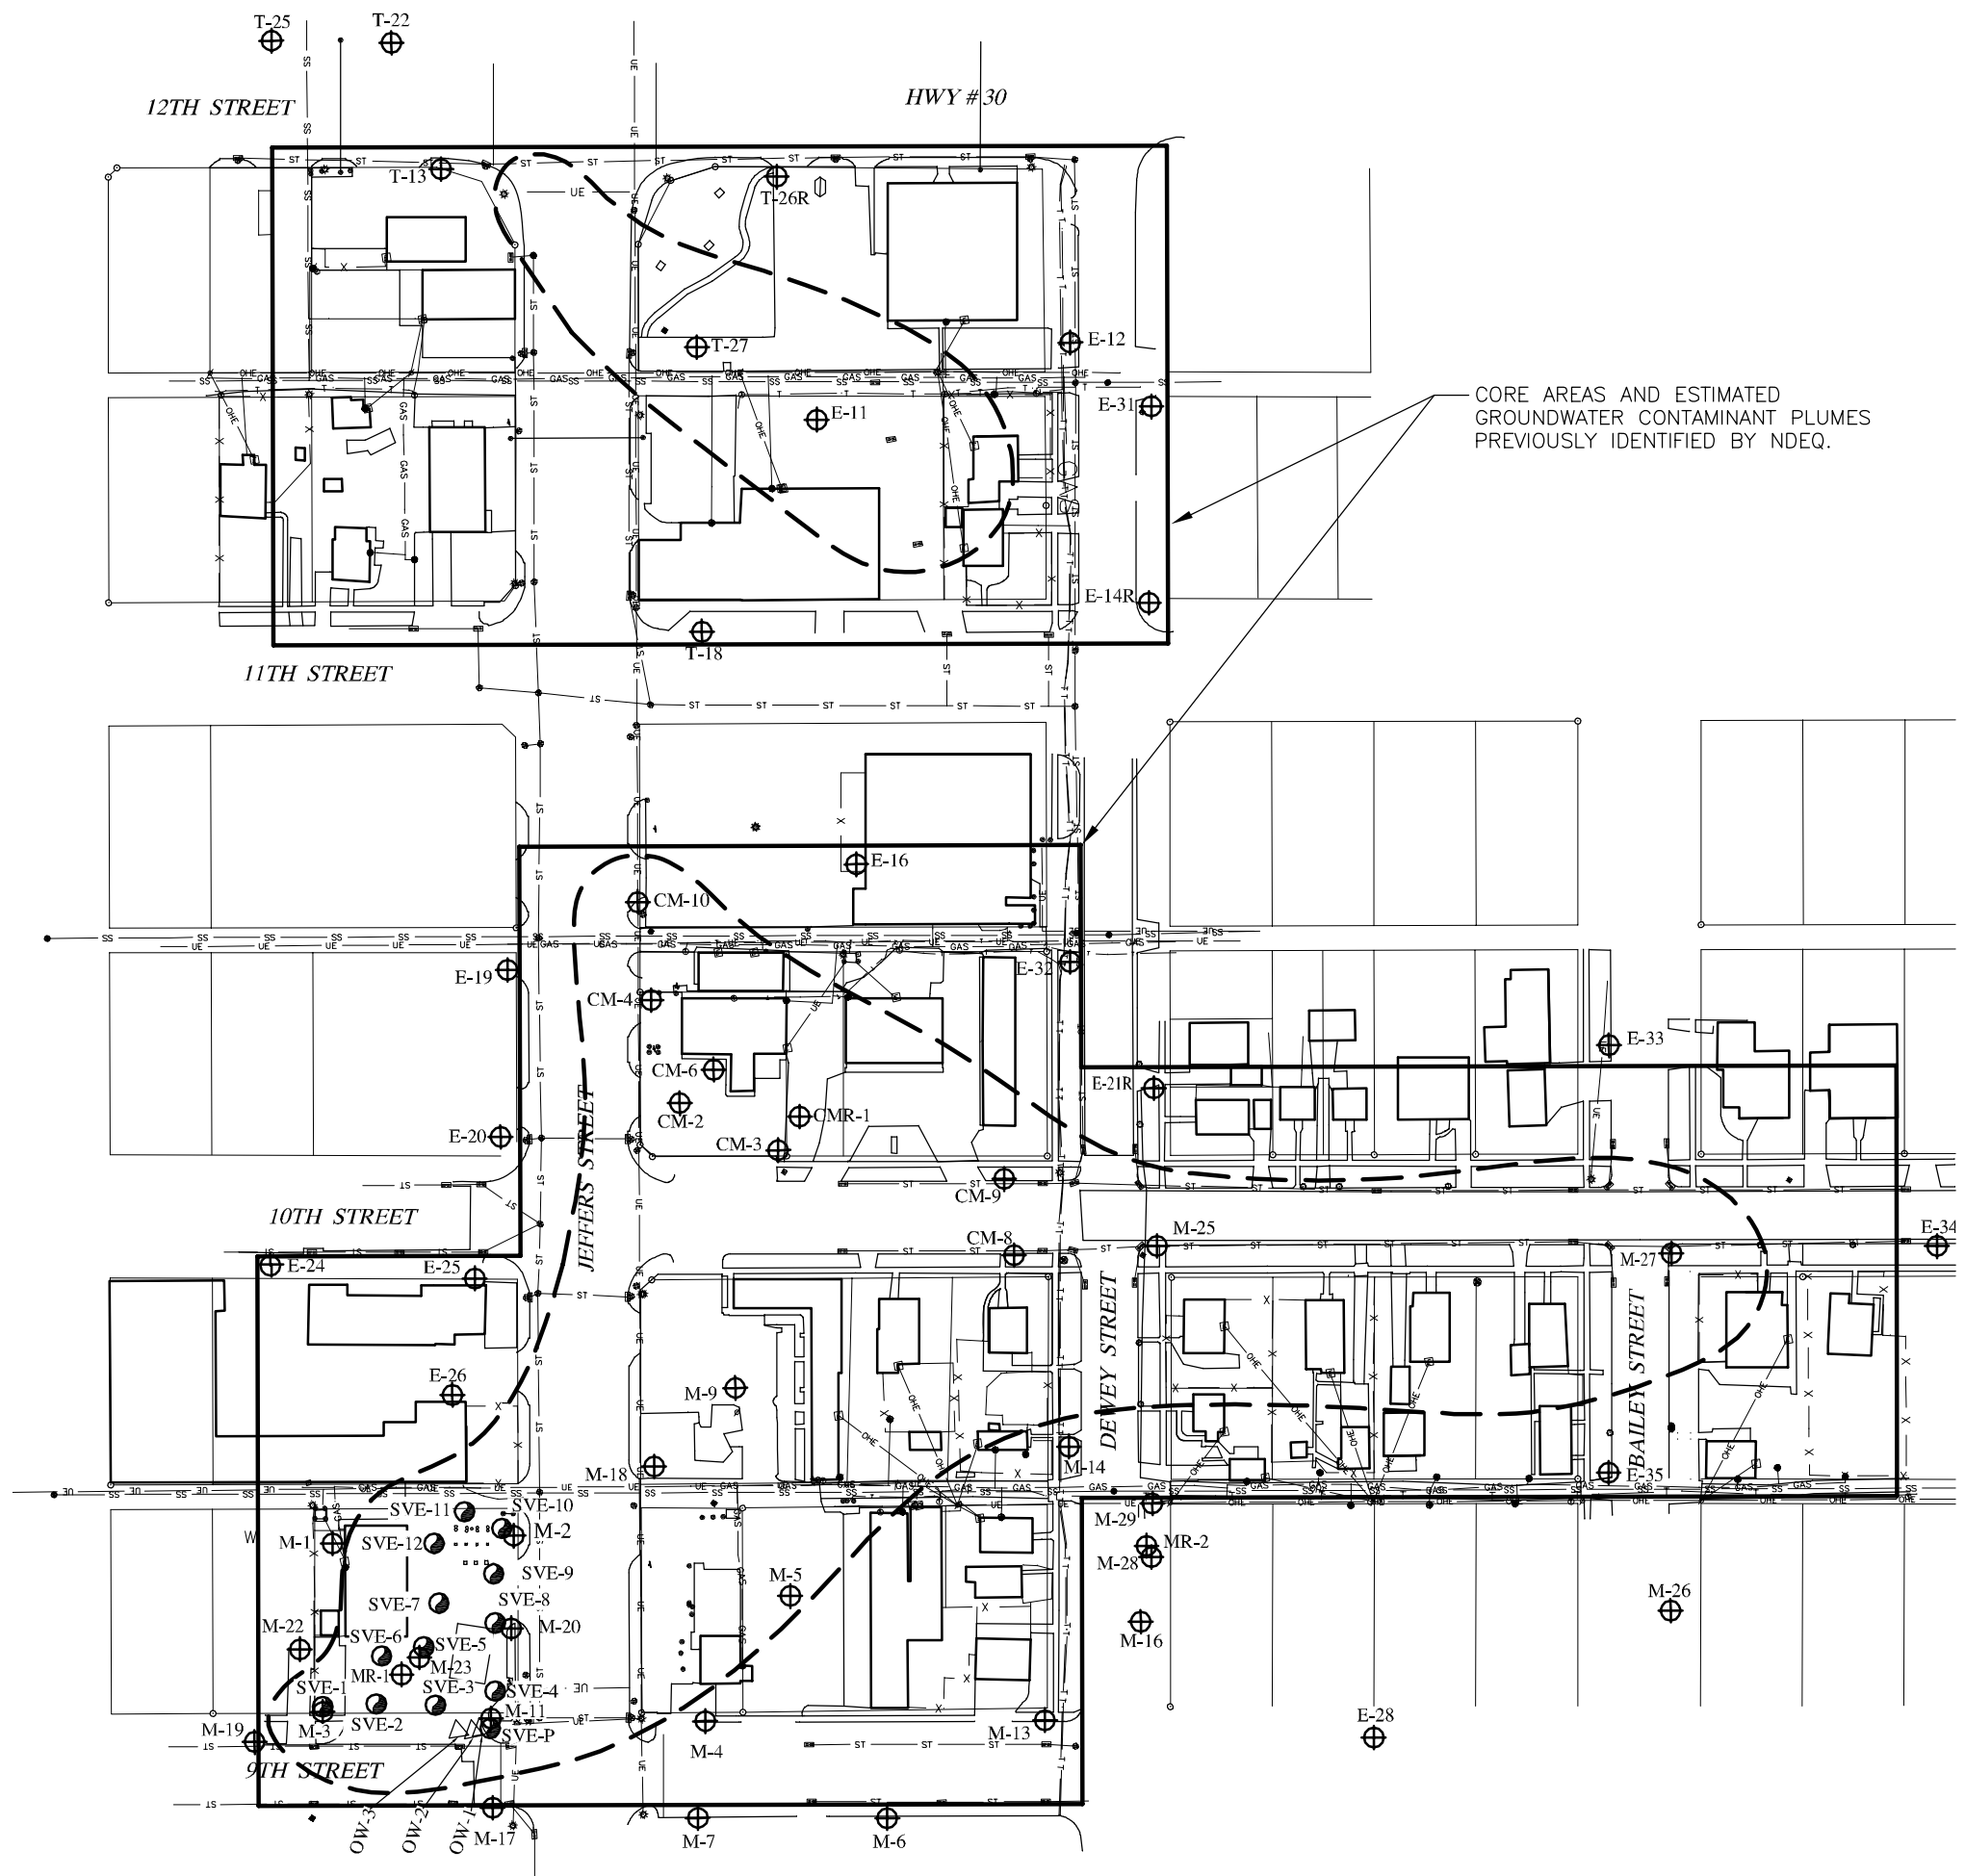
CORE AREAS AND ESTIMATED GROUNDWATER CONTAMINANT PLUMES PREVIOUSLY IDENTIFIED BY NDEQ.

**NOTE:**  
 1.) MONITORING WELLS M-28, M-29 AND RECOVERY WELL MR-2 WERE NOT PROFESSIONALLY SURVEYED. LOCATIONS FOR M-28, M-29, AND MR-2 WERE REFERENCED TO STREET AND ALLEYWAY CENTERLINES BASED ON FIELD MEASUREMENTS OBTAINED WITH A MEASURING WHEEL. MONITORING WELLS E-10, E-13, AND T-17 WERE INTENDED FOR SURVEYING, HOWEVER THEY COULD NOT BE LOCATED BY THE ENVIRONMENTAL PROFESSIONAL AND SURVEY CREW AND ARE PRESUMED LOST.
