BENZENE CONTAMINANT PLUME MAP – APRIL 2008		
NORTH JEFFERS PETROLEUM SITES		
NORTH JEFFERS STREET		
NORTH PLATTE, NEBRASKA		
Project Mngr:	KAC	Project No. 05037186
Designed By:	KAC	Scale: AS SHOWN
Drawn By:	PAI	File No. 05037186C18
Checked By:	KAC	Date: JUNE 2008
Approved By:	MEH	FIGURE NO. 5

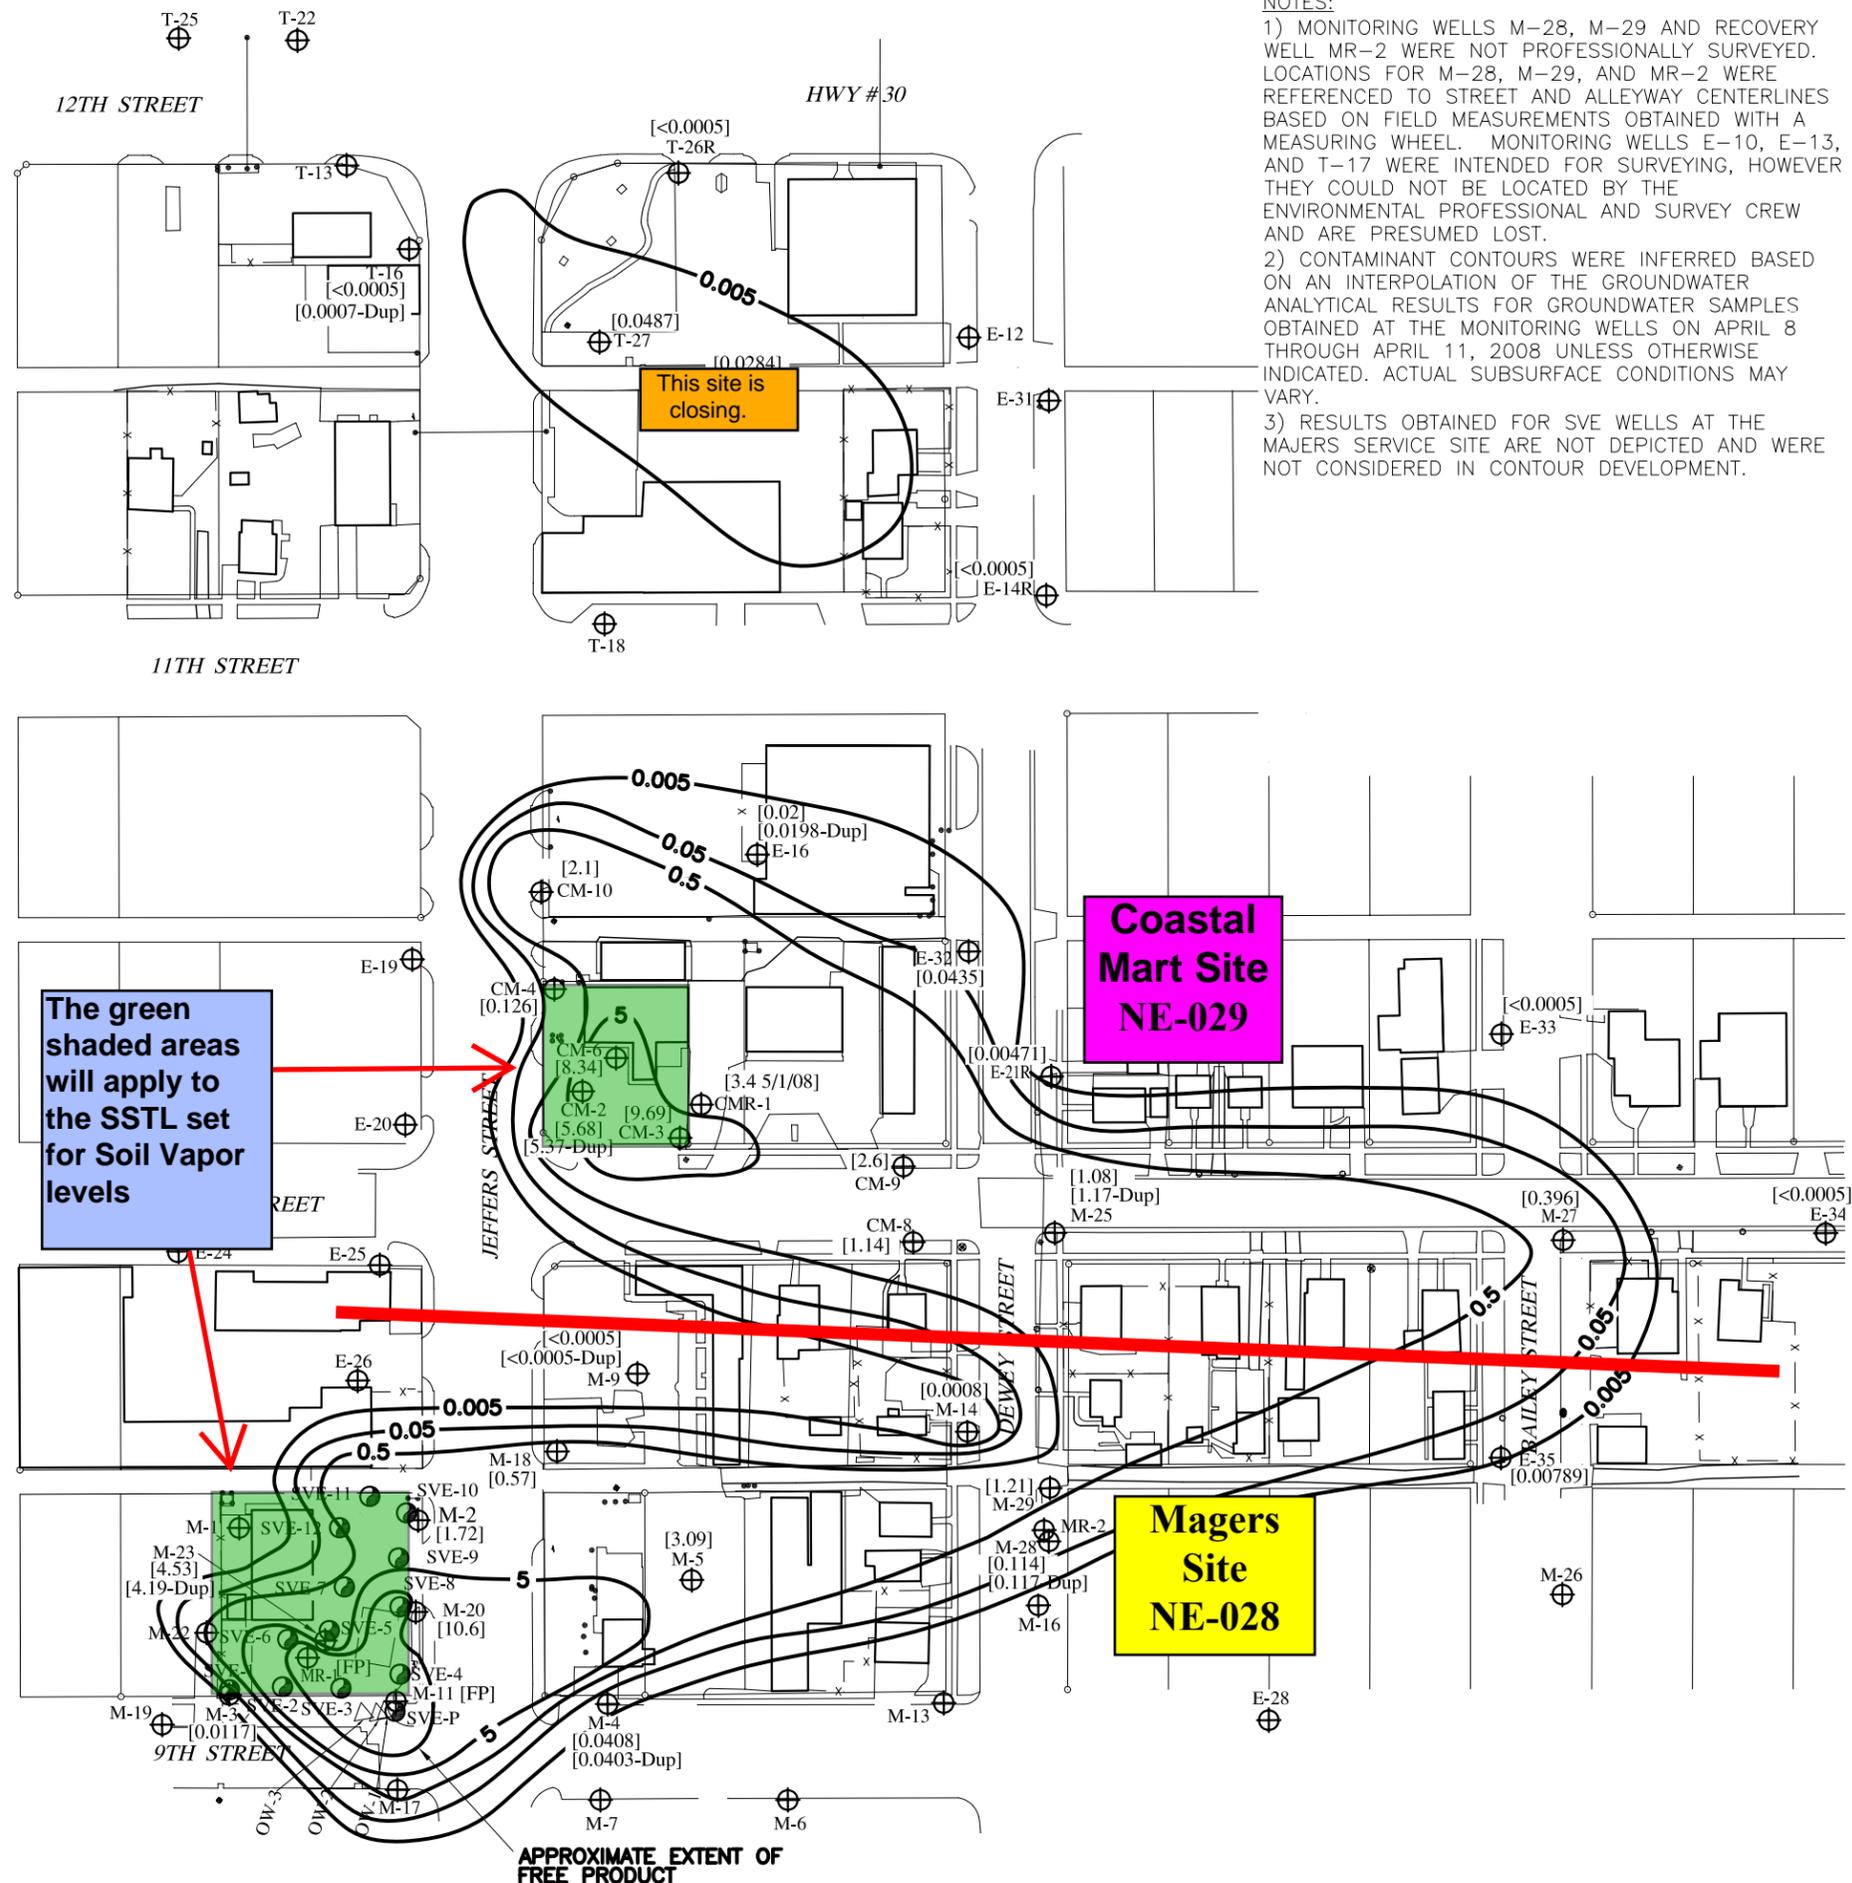
2) CONTAMINANT CONTOURS WERE INFERRED BASED ON AN INTERPOLATION OF THE GROUNDWATER ANALYTICAL RESULTS FOR GROUNDWATER SAMPLES OBTAINED AT THE MONITORING WELLS ON APRIL 8 THROUGH APRIL 11, 2008 UNLESS OTHERWISE INDICATED. ACTUAL SUBSURFACE CONDITIONS MAY VARY.
